**Re: Lee Ranch Coal Mine; Minor Individual Permit; SIC 1221; NPDES Compliance Evaluation Inspection;
NM0029581; September 9, 2019**

NPDES Compliance Inspection Report

Peabody Natural Resources Company dba Lee Ranch Coal Company
Lee Ranch Coal Mine
NPDES Permit No. NM0029581
Compliance Evaluation Inspection
September 9, 2019

Further Explanations

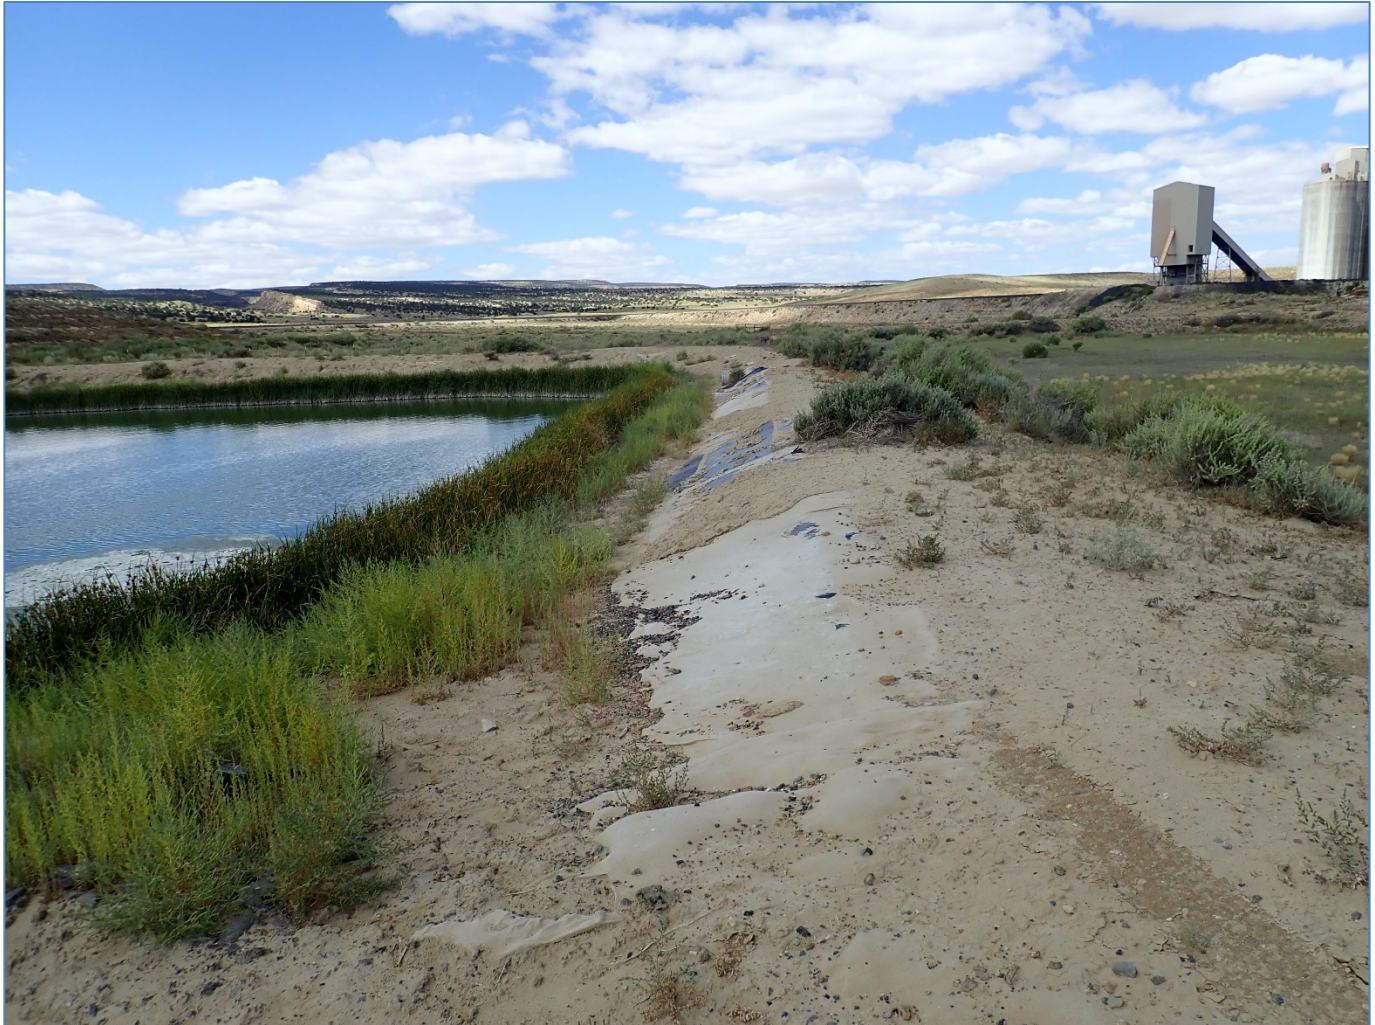
**NMED/SWQB
Official Photograph Log
Photo # 1**

- Domestic wastewater discharge is no longer authorized under the 2018 Final Permit. The domestic wastewater lagoon liner had tear and vegetation was overgrown in and around the liner (see Photos 1 and 2 below). An evaluation of the liner integrity and maintenance schedule appears needed. No evidence of recent flow from the lagoon into the overflow impoundment was observed. The overflow impoundment is approximately 1,000 feet east of Mulatto Canyon.

Photographer: Erin Shea	Date: 09/09/2019	Time: ~1153 hours
City/County: North of Milan / McKinley County		State: New Mexico
Location: Lee Ranch Coal Mine / NPDES Permit No. NM0029581		
Subject: Treated domestic wastewater is piped to the lined sewage lagoon shown on the left side of this photo. An corrugated metal pipe (also shown in Photo 2) would allow flow from the lined lagoon to the overflow impoundment on the right side of this photo.

As noted in the inspection the sewage lagoon is no longer listed on the LRM NPDES permit. The LRM is currently in a care and maintenance state with minimal staff and equipment onsite and the mine is not actively extracting coal. Because of the limited amount of personnel onsite the lagoon receives negligible inflow relative to its design capacity and has little to no potential for discharge. Furthermore, the sewage lagoon is part of an in-series treatment system that would report to Outfall 044 before discharging off-site. The sewage lagoon is permitted under the NMED Ground Water Quality Bureau's Groundwater Discharge Program (Permit # DP-777). PNRC and the NMED Ground Water Quality Bureau are currently working on a plan to correct the conditions of the lagoon.

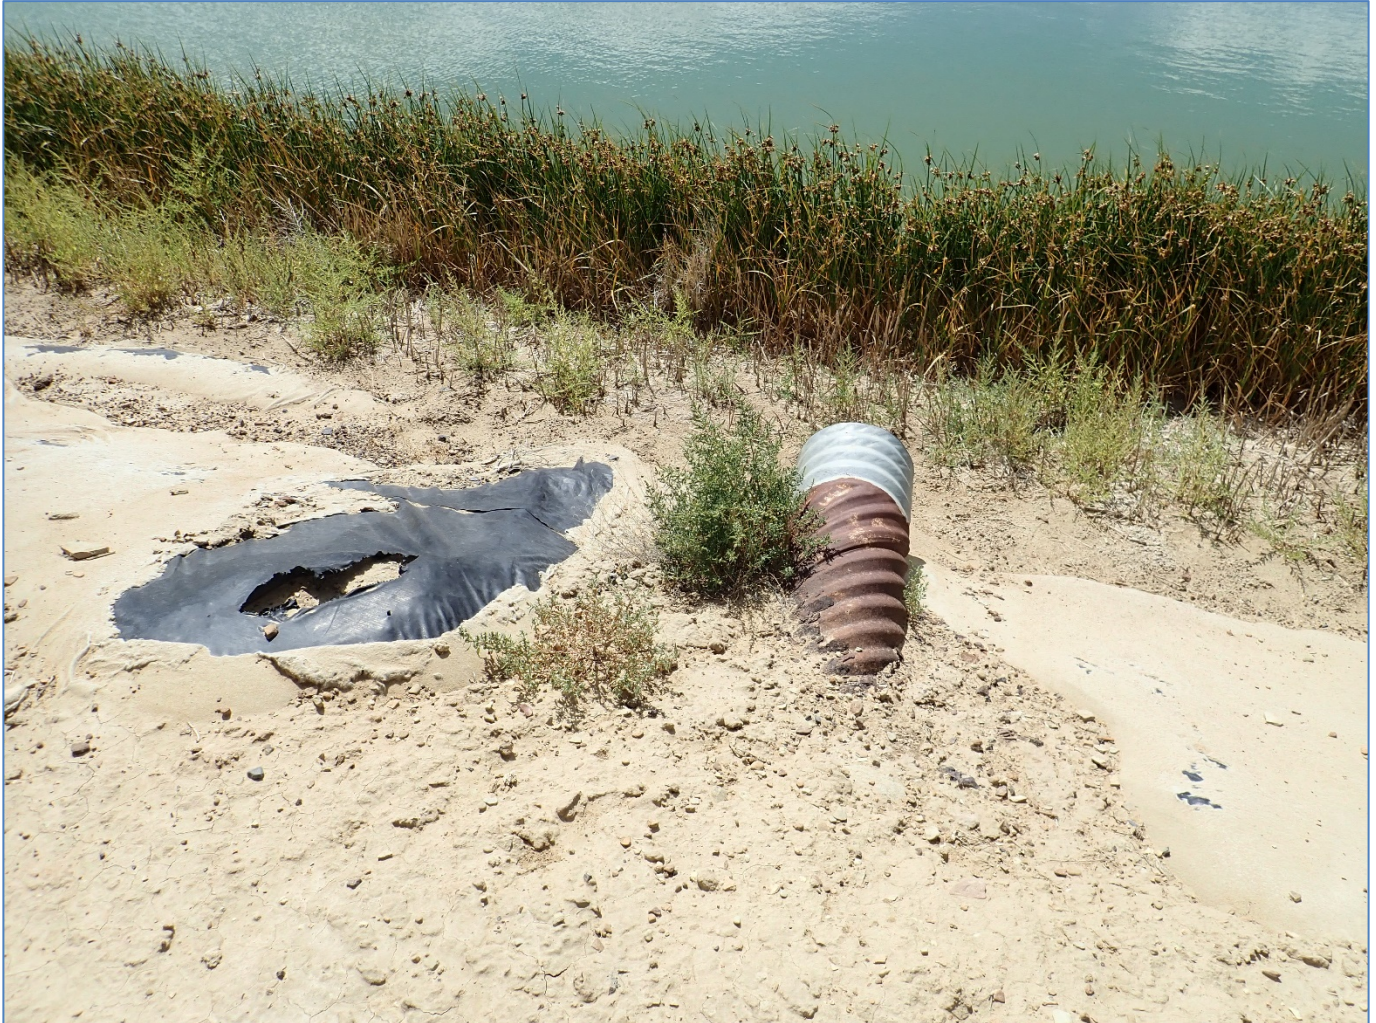
**NMED/SWQB
Official Photograph Log
Photo # 2**

2. TREATMENT UNITS PROPERLY MAINTAINED. Domestic wastewater lagoon had tear. Vegetation overgrown.	<input type="checkbox"/> S <input checked="" type="checkbox"/> M <input type="checkbox"/> U <input type="checkbox"/> NA

Photographer: Erin Shea	Date: 09/09/2019	Time: ~1154 hours
City/County: North of Milan / McKinley County		State: New Mexico
Location: Lee Ranch Coal Mine / NPDES Permit No. NM0029581		
Subject: Domestic wastewater lagoon liner had tear. Vegetation was overgrown in and around the liner.
